SMOKE TESTING OBSERVATION SUMMARY

Western Run Pilot Project - Baltimore Maryland

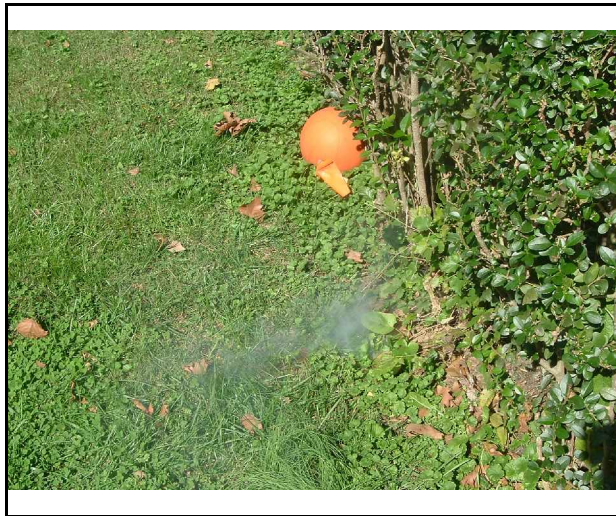
Photo No: 12

Source Type:	02= Service Line	Location:	7=Yard-Front	Severity:	3=Moderate
---------------------	------------------	------------------	--------------	------------------	------------

Comments: hole

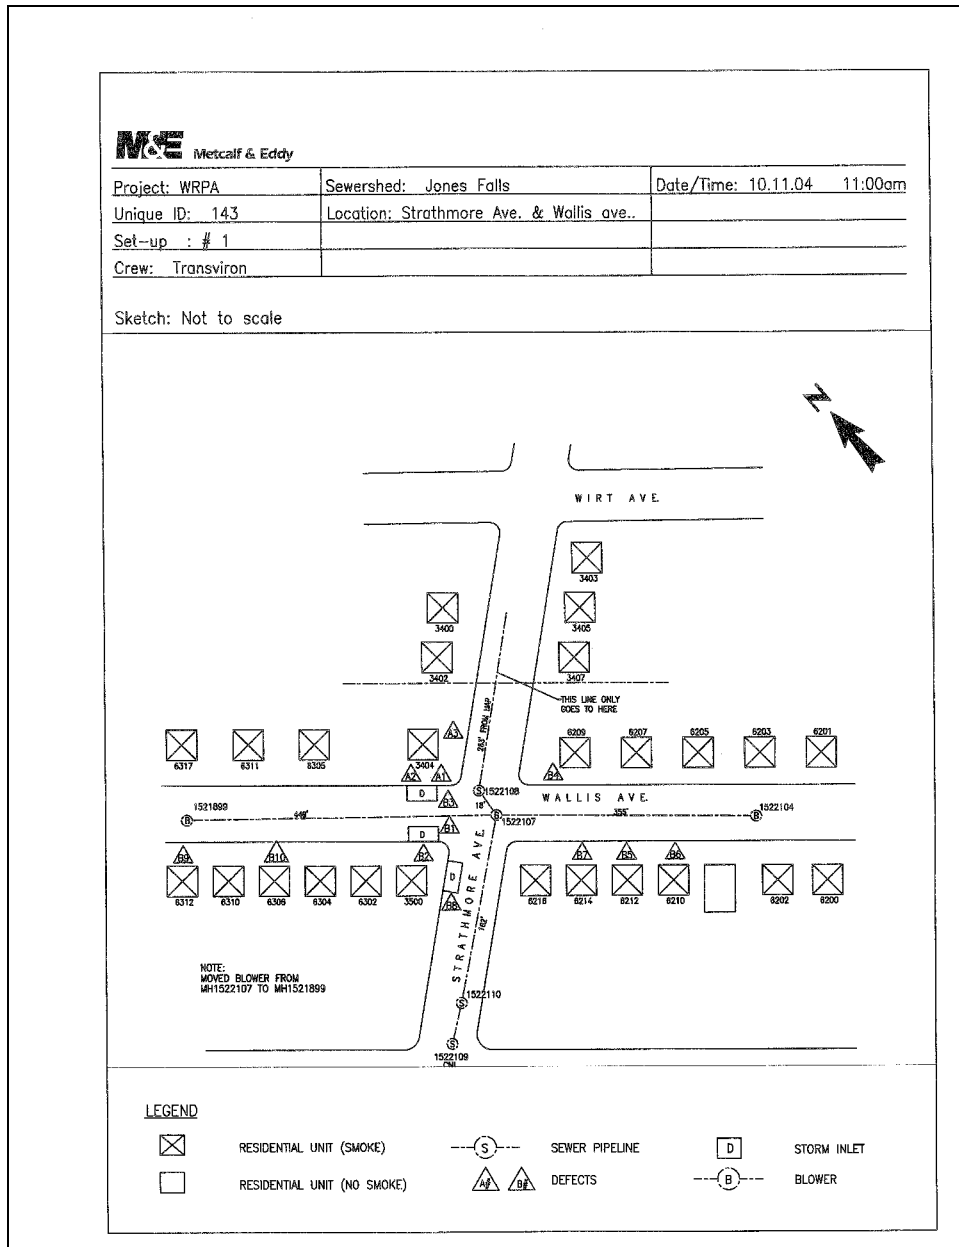
Sketch No: 143

Unique Test ID	143	Date:	10/11/2004	MeterBasin:	01_WR05
Observer ID:	B	Crew:	T-1	Dye Test Recommended:	N
Defect No:	7	Setup No:	1	Priority CCTV:

House Number	Street Prefix:	Street Name:	Street Type:
6214		Wallis	AVE

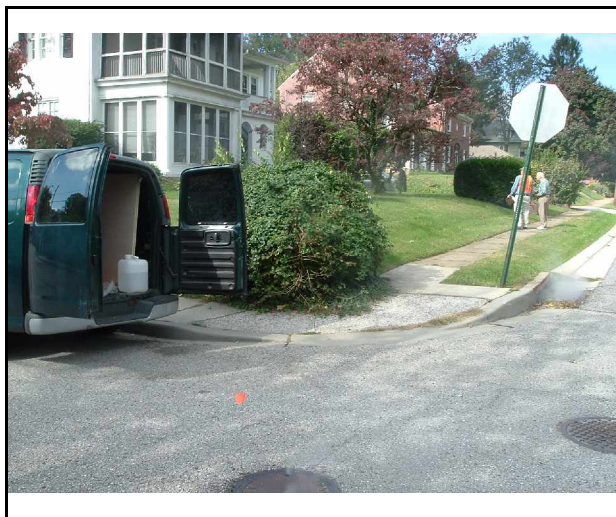
Photo No: 2

House Number	3500	Street Prefix:		Street Name:	W Strathmore	Street Type:	AVE
Source Type:	14= Catch Basin	Location:	6=Curb	Severity:	3=Moderate		
Sector:	1=Public	Drainage Area:	1000				
Comments:

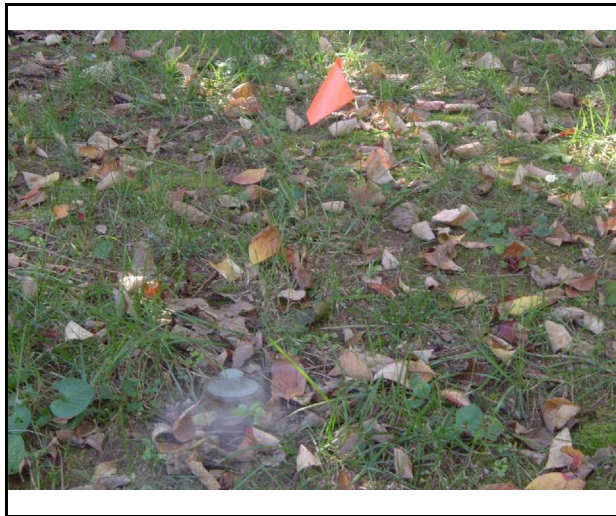
Photo No: 15

Source Type:	04= Cleanout	Location:	7=Yard-Front	Severity:	2=Trace
Sector:	2=Private	Drainage Area:	0

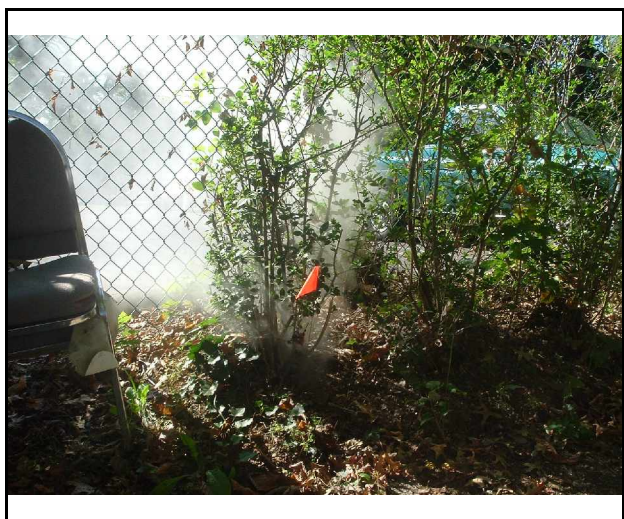
Photo No: 5

Source Type:	04= Cleanout	Location:	8=Yard-Back	Severity:	3=Moderate
Sector:	2=Private	Drainage Area:	25

Comments: alley

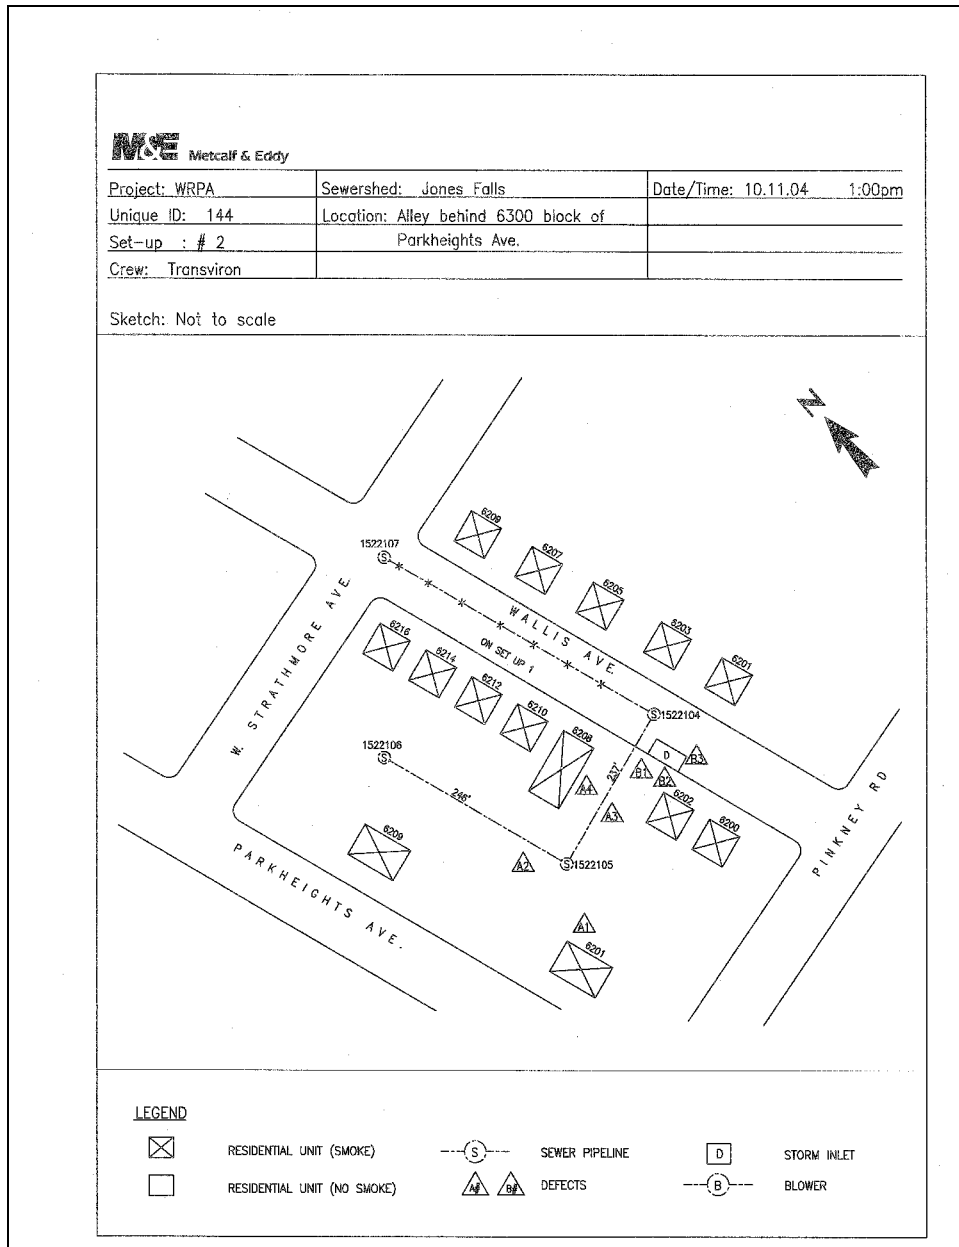
Sketch No: 144

Unique Test ID	144	Date:	10/11/2004	MeterBasin:	01_WR05
Observer ID:	A	Crew:	T-1	Dye Test Recommended:	N
Defect No:	1	Setup No:	2	Priority CCTV:

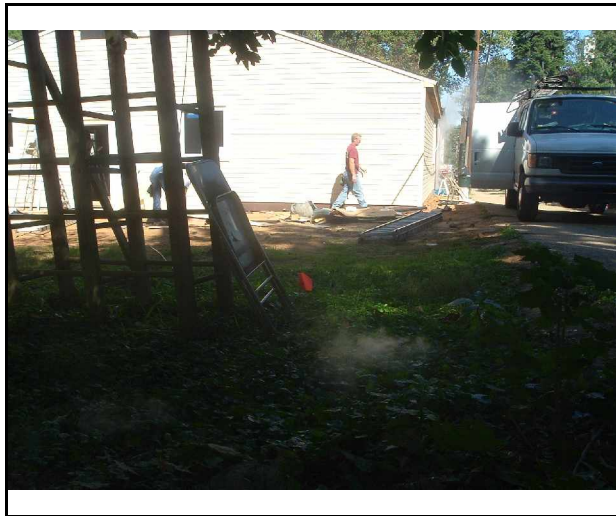
Photo No: 7

Unique Test ID	144	Date:	10/11/2004	MeterBasin:	
Observer ID:	A	Crew:	T-1	Dye Test Recommended:	N
Defect No:	2	Setup No:	2	Priority CCTV:	
House Number	6208	Street Prefix:		Street Name:	Wallis
				Street Type:	AVE
Source Type:	02= Service Line	Location:	12=Alley	Severity:	4=Major
Sector:	1=Public	Drainage Area:	50		
Comments:	Hole(rear of building)

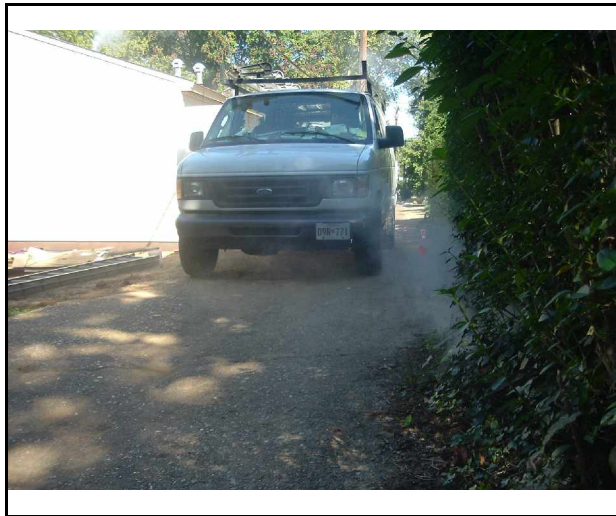
Photo No: 8

House Number	6202	Street Prefix:		Street Name:	Wallis	Street Type:	AVE
Source Type:	02= Service Line	Location:	12=Alley	Severity:	4=Major		
Sector:	1=Public	Drainage Area:	100				
Comments:	Hole

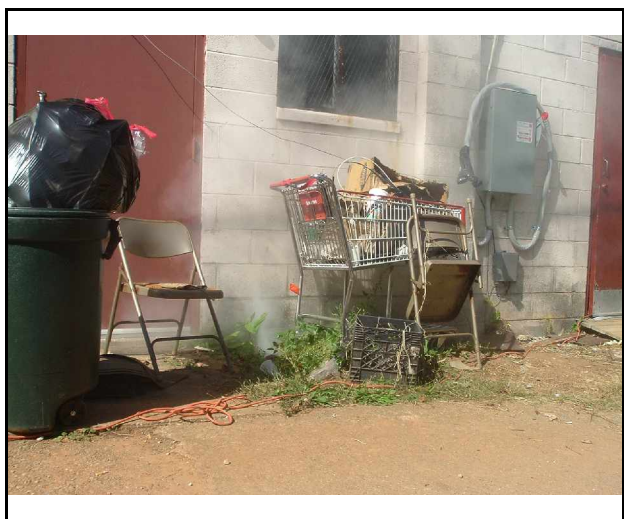
Photo No: 9

House Number	Street Prefix:	Street Name:	Street Type:		
6208		Wallis	AVE		
Source Type:	04= Cleanout	Location:	9=Yard-Side	Severity:	3=Moderate
Sector:	2=Private	Drainage Area:	10		
Comments:

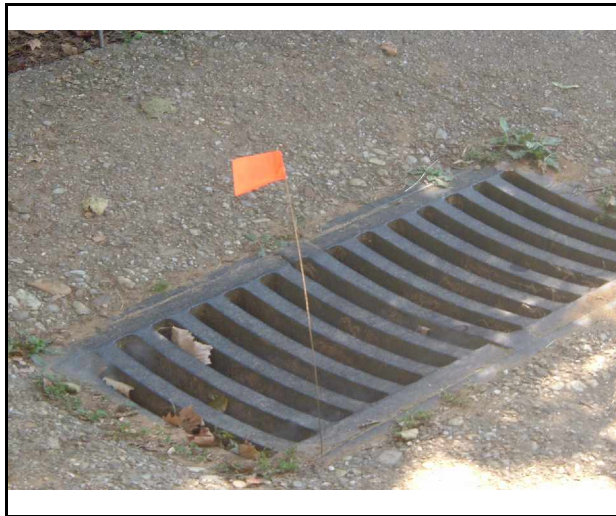
Photo No: 19

Source Type:	14= Catch Basin	Location:	12=Alley	Severity:	4=Major
Sector:	1=Public	Drainage Area:	2700

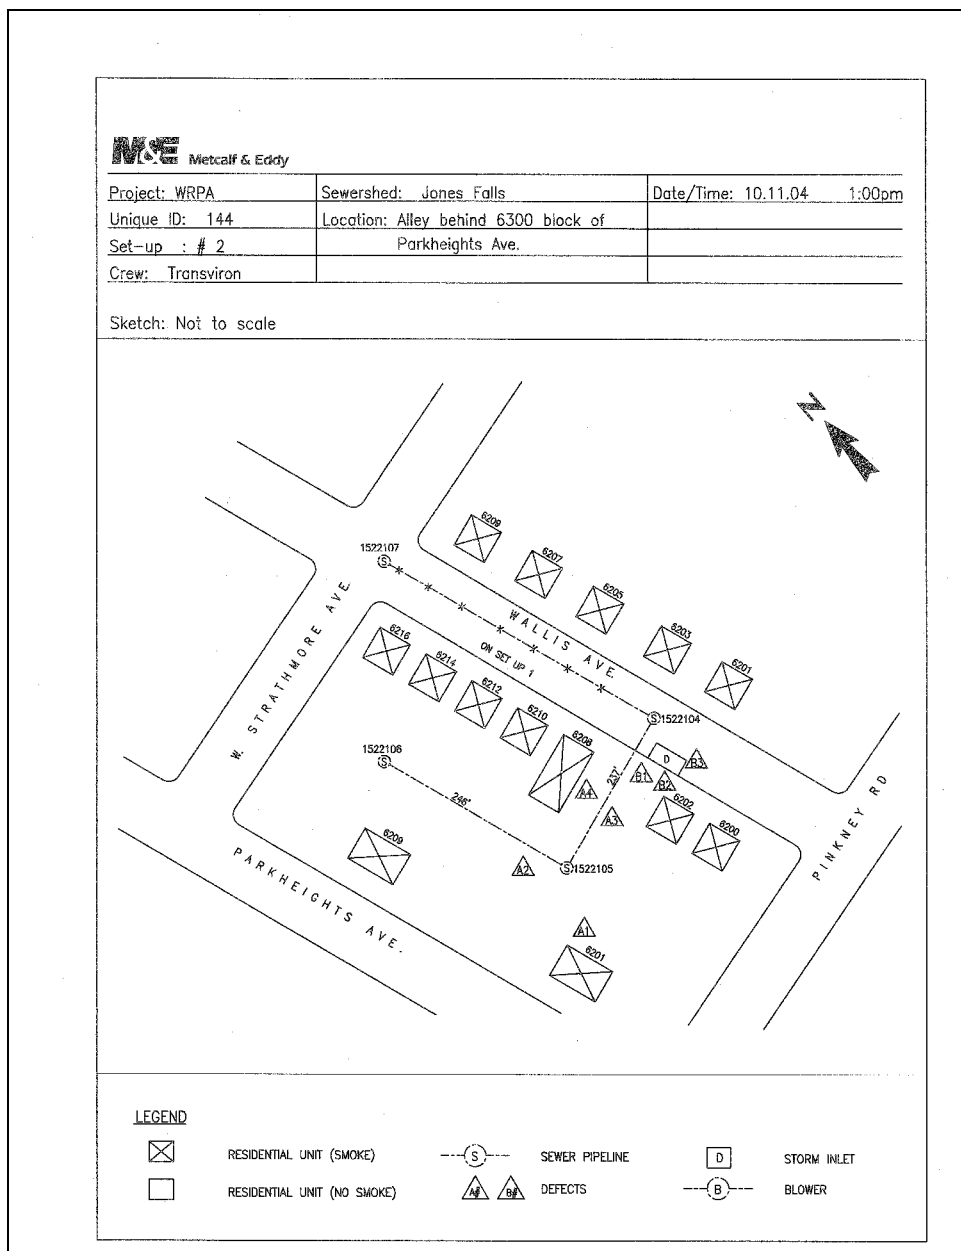
Sketch No: 144

Unique Test ID	144	Date:	10/11/2004	MeterBasin:	01_WR05
Observer ID:	B	Crew:	T-1	Dye Test Recommended:	Y
Defect No:	1	Setup No:	2	Priority CCTV:

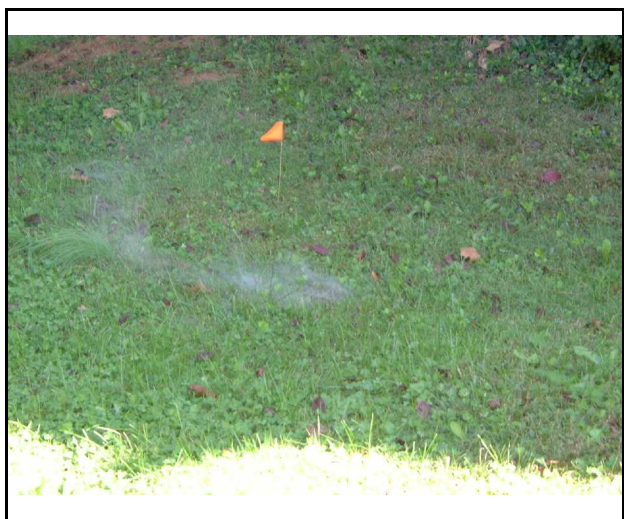
Photo No: 21

Source Type:	04= Cleanout	Location:	9=Yard-Side	Severity:	2=Trace
Sector:	2=Private	Drainage Area:	50

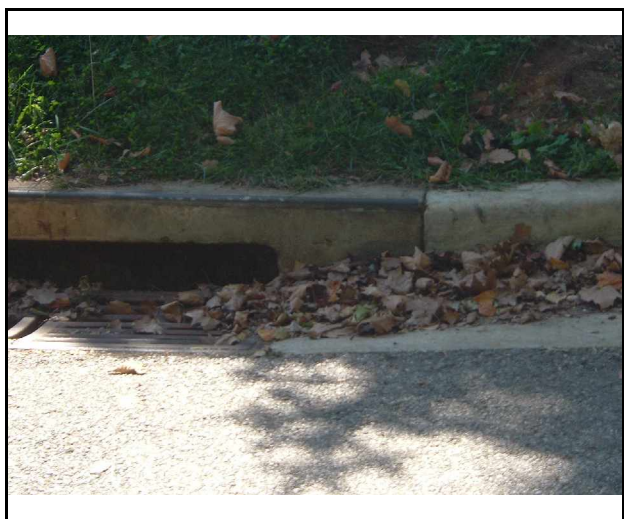
Photo No: 23

Source Type:	14= Catch Basin	Location:	6=Curb	Severity:	2=Trace
Sector:	1=Public	Drainage Area:	1000
